ESKIMO II. MAGAZINE SEPARATION TEST

Naval Weapons Center  
China Lake, California

September 1974

NWC Technical Publication 5557

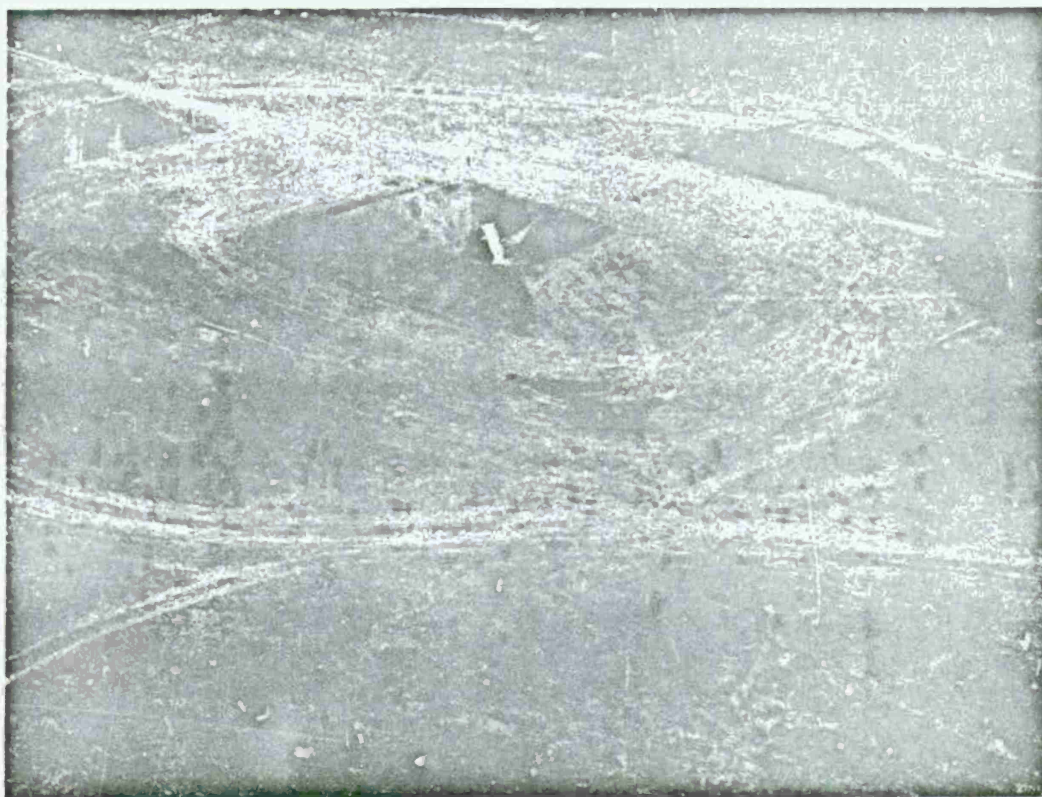
Figure 9. Aerial View of the Test Site Prior to the Detonation Showing the Stack of M117 Bombs Used as a Donor Charge. Also visible are the five acceptor magazines.

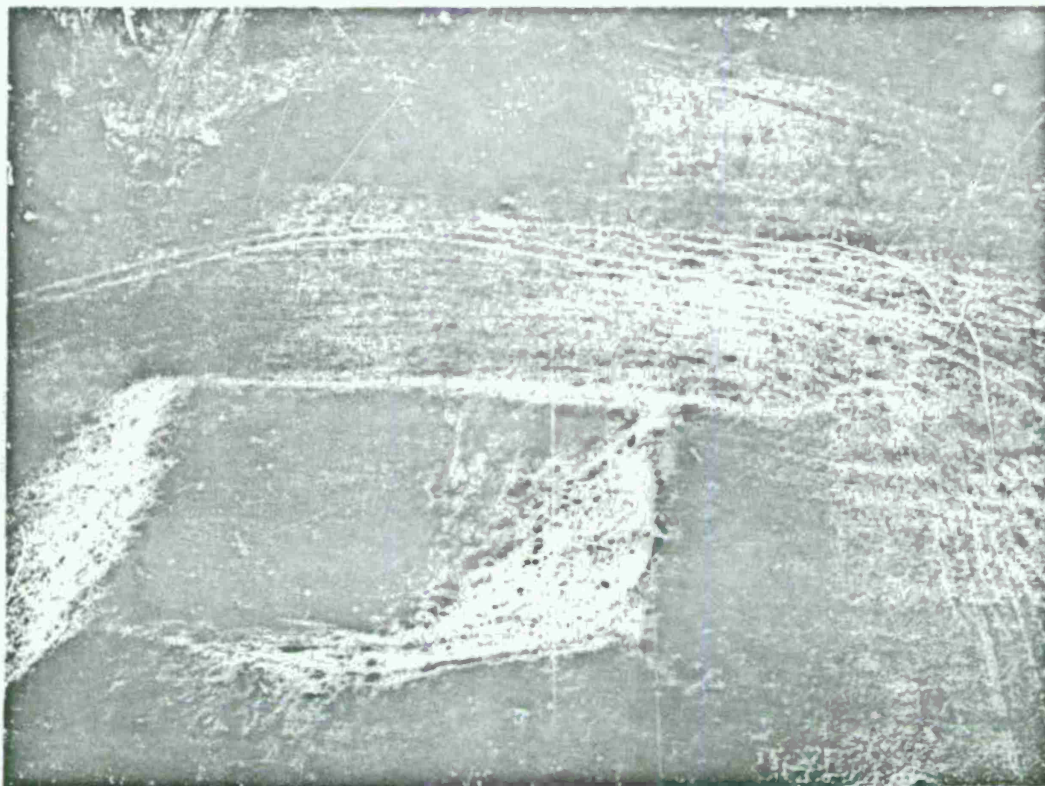
Figure 14. Test Site After Detonation. Note that earth revetment around donor remains essentially intact. D Magazine is in the background.

complete, or essentially complete, detonation was achieved. The crater produced was basically a deepening of the 20- by 20-foot area within the four-sided earth embankment surrounding the donor charge. The interior sides of the embankment were eroded only slightly and the top of the embankment was not breached by the explosion (Figure 14). Varying amounts of structural damage were incurred by the test magazines. Details on this damage are presented with illustrations in the following sections.

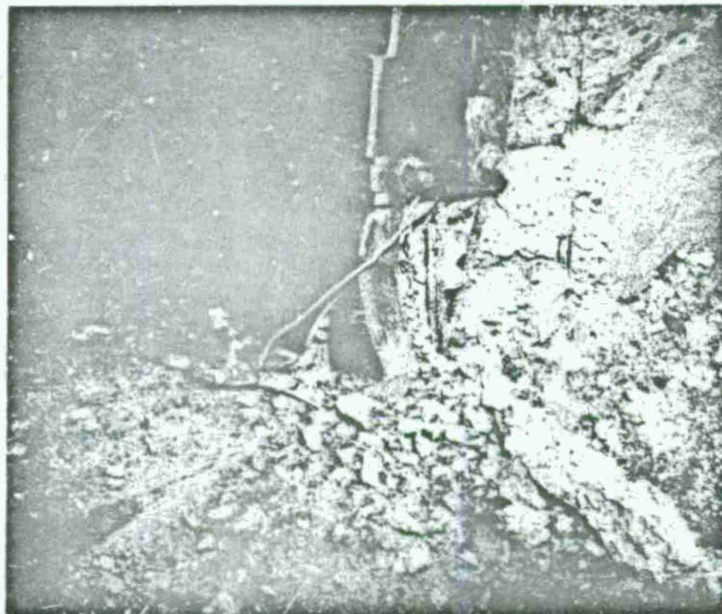
1. The doors were thrown inward by the blast and, after experiencing considerable bending and distortion, they came to rest in the interior of the igloo (Figures 23-25).
2. The headwall cracking pattern resembled that of the igloos of ESKIMO I (Figures 26 and 27). The permanent deformation incurred was greater than that experienced by either the south igloo or the right side of the west igloo of ESKIMO I.

Figure 25. Hinge Plate and Bottom of Door Jamb on Igloo C Showing Method of Failure.

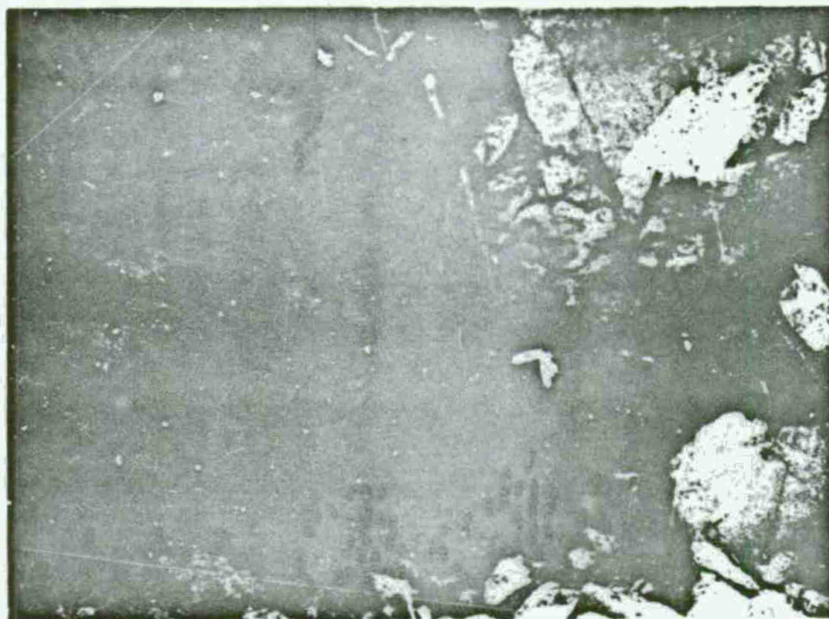
2. Essentially all of the portion of the headwall that adjoined the interior magazine space (the space under the arch) was destroyed (Figures 32-34). It is believed that the headwall carried all the blast load impinging on the headwall and door and did not benefit by the load relief afforded at the other magazines by door failure or rotation. The upper corners of the headwall moved forward about 3 inches.

Figure 33. Looking Into Igloo D From Doorway Showing Shattered Headwall and Warped Door. None of the 12 mines in this magazine exploded or burned; one was badly shattered.

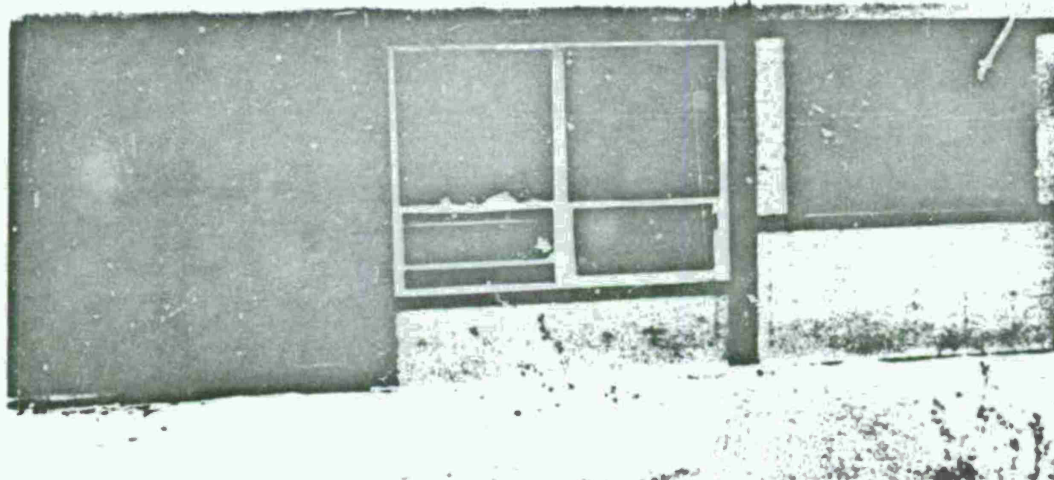
Window Cubes at 17,000 Feet. All window panes were broken out except one.
